Full-mouth implants for mandibular & maxilla - restored using mixed prostheses

Dr. Hyun Jun Kim

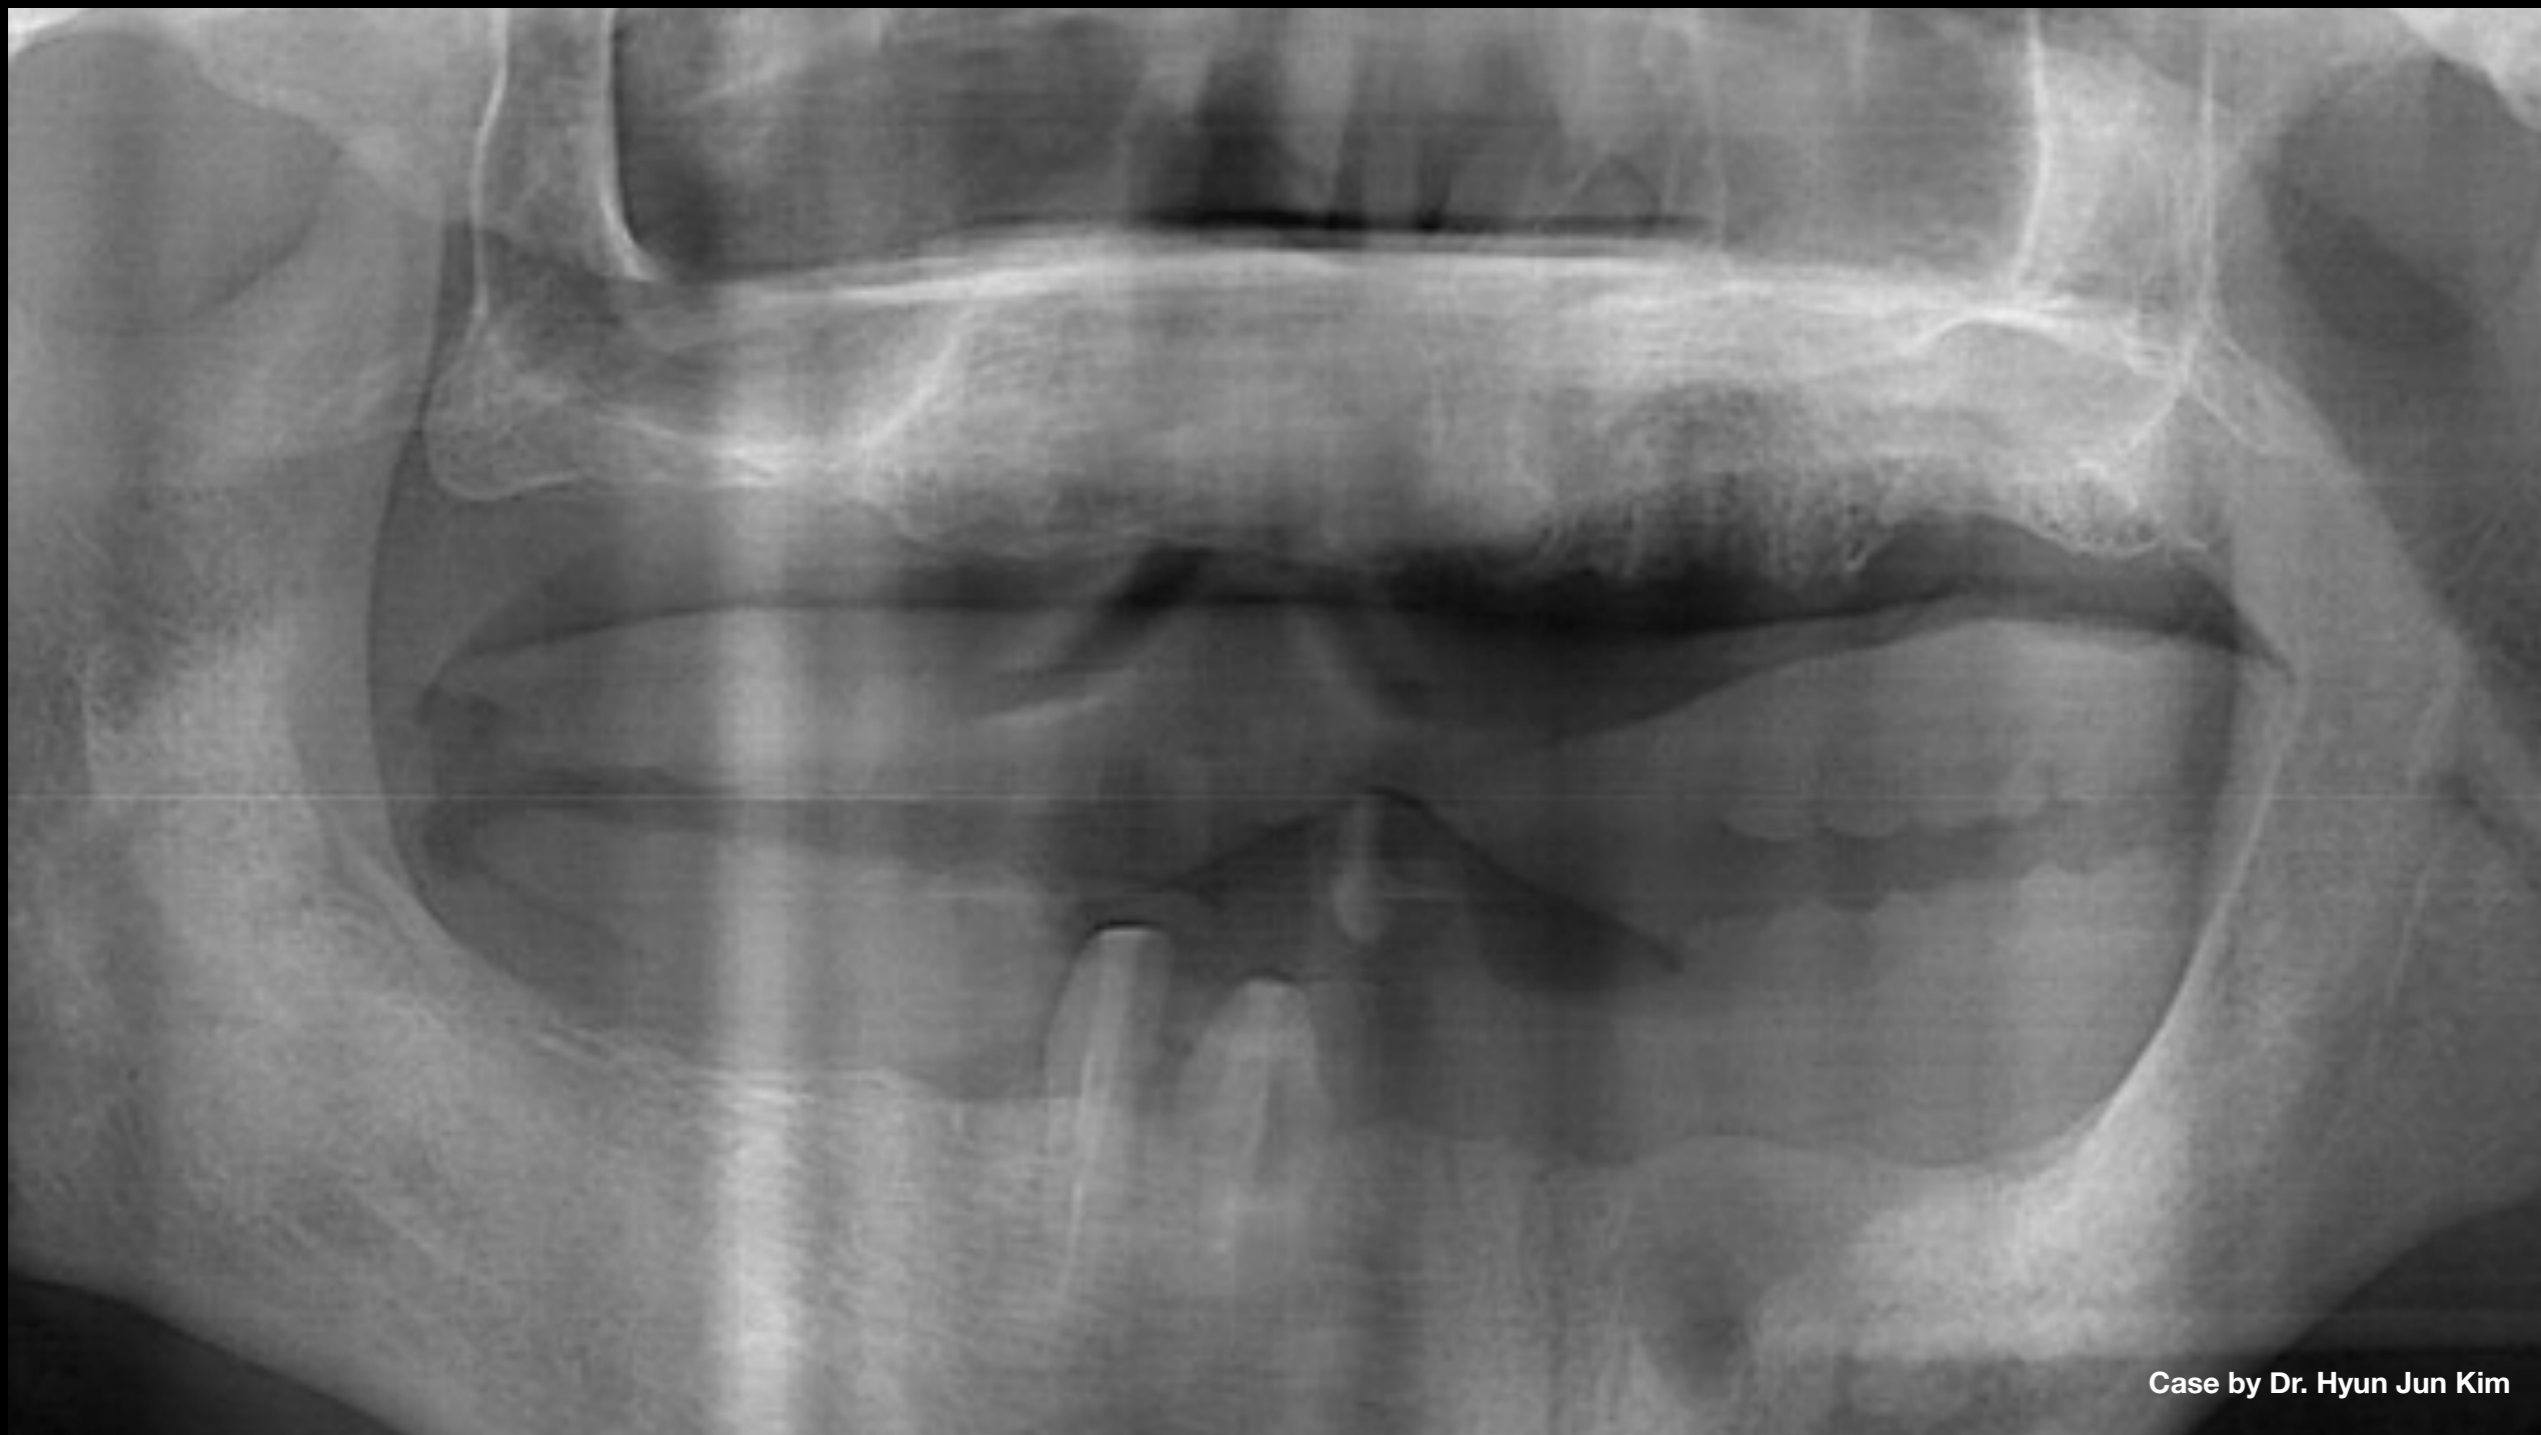
**Clinical Case:** Extraction of all teeth except #43 & 44

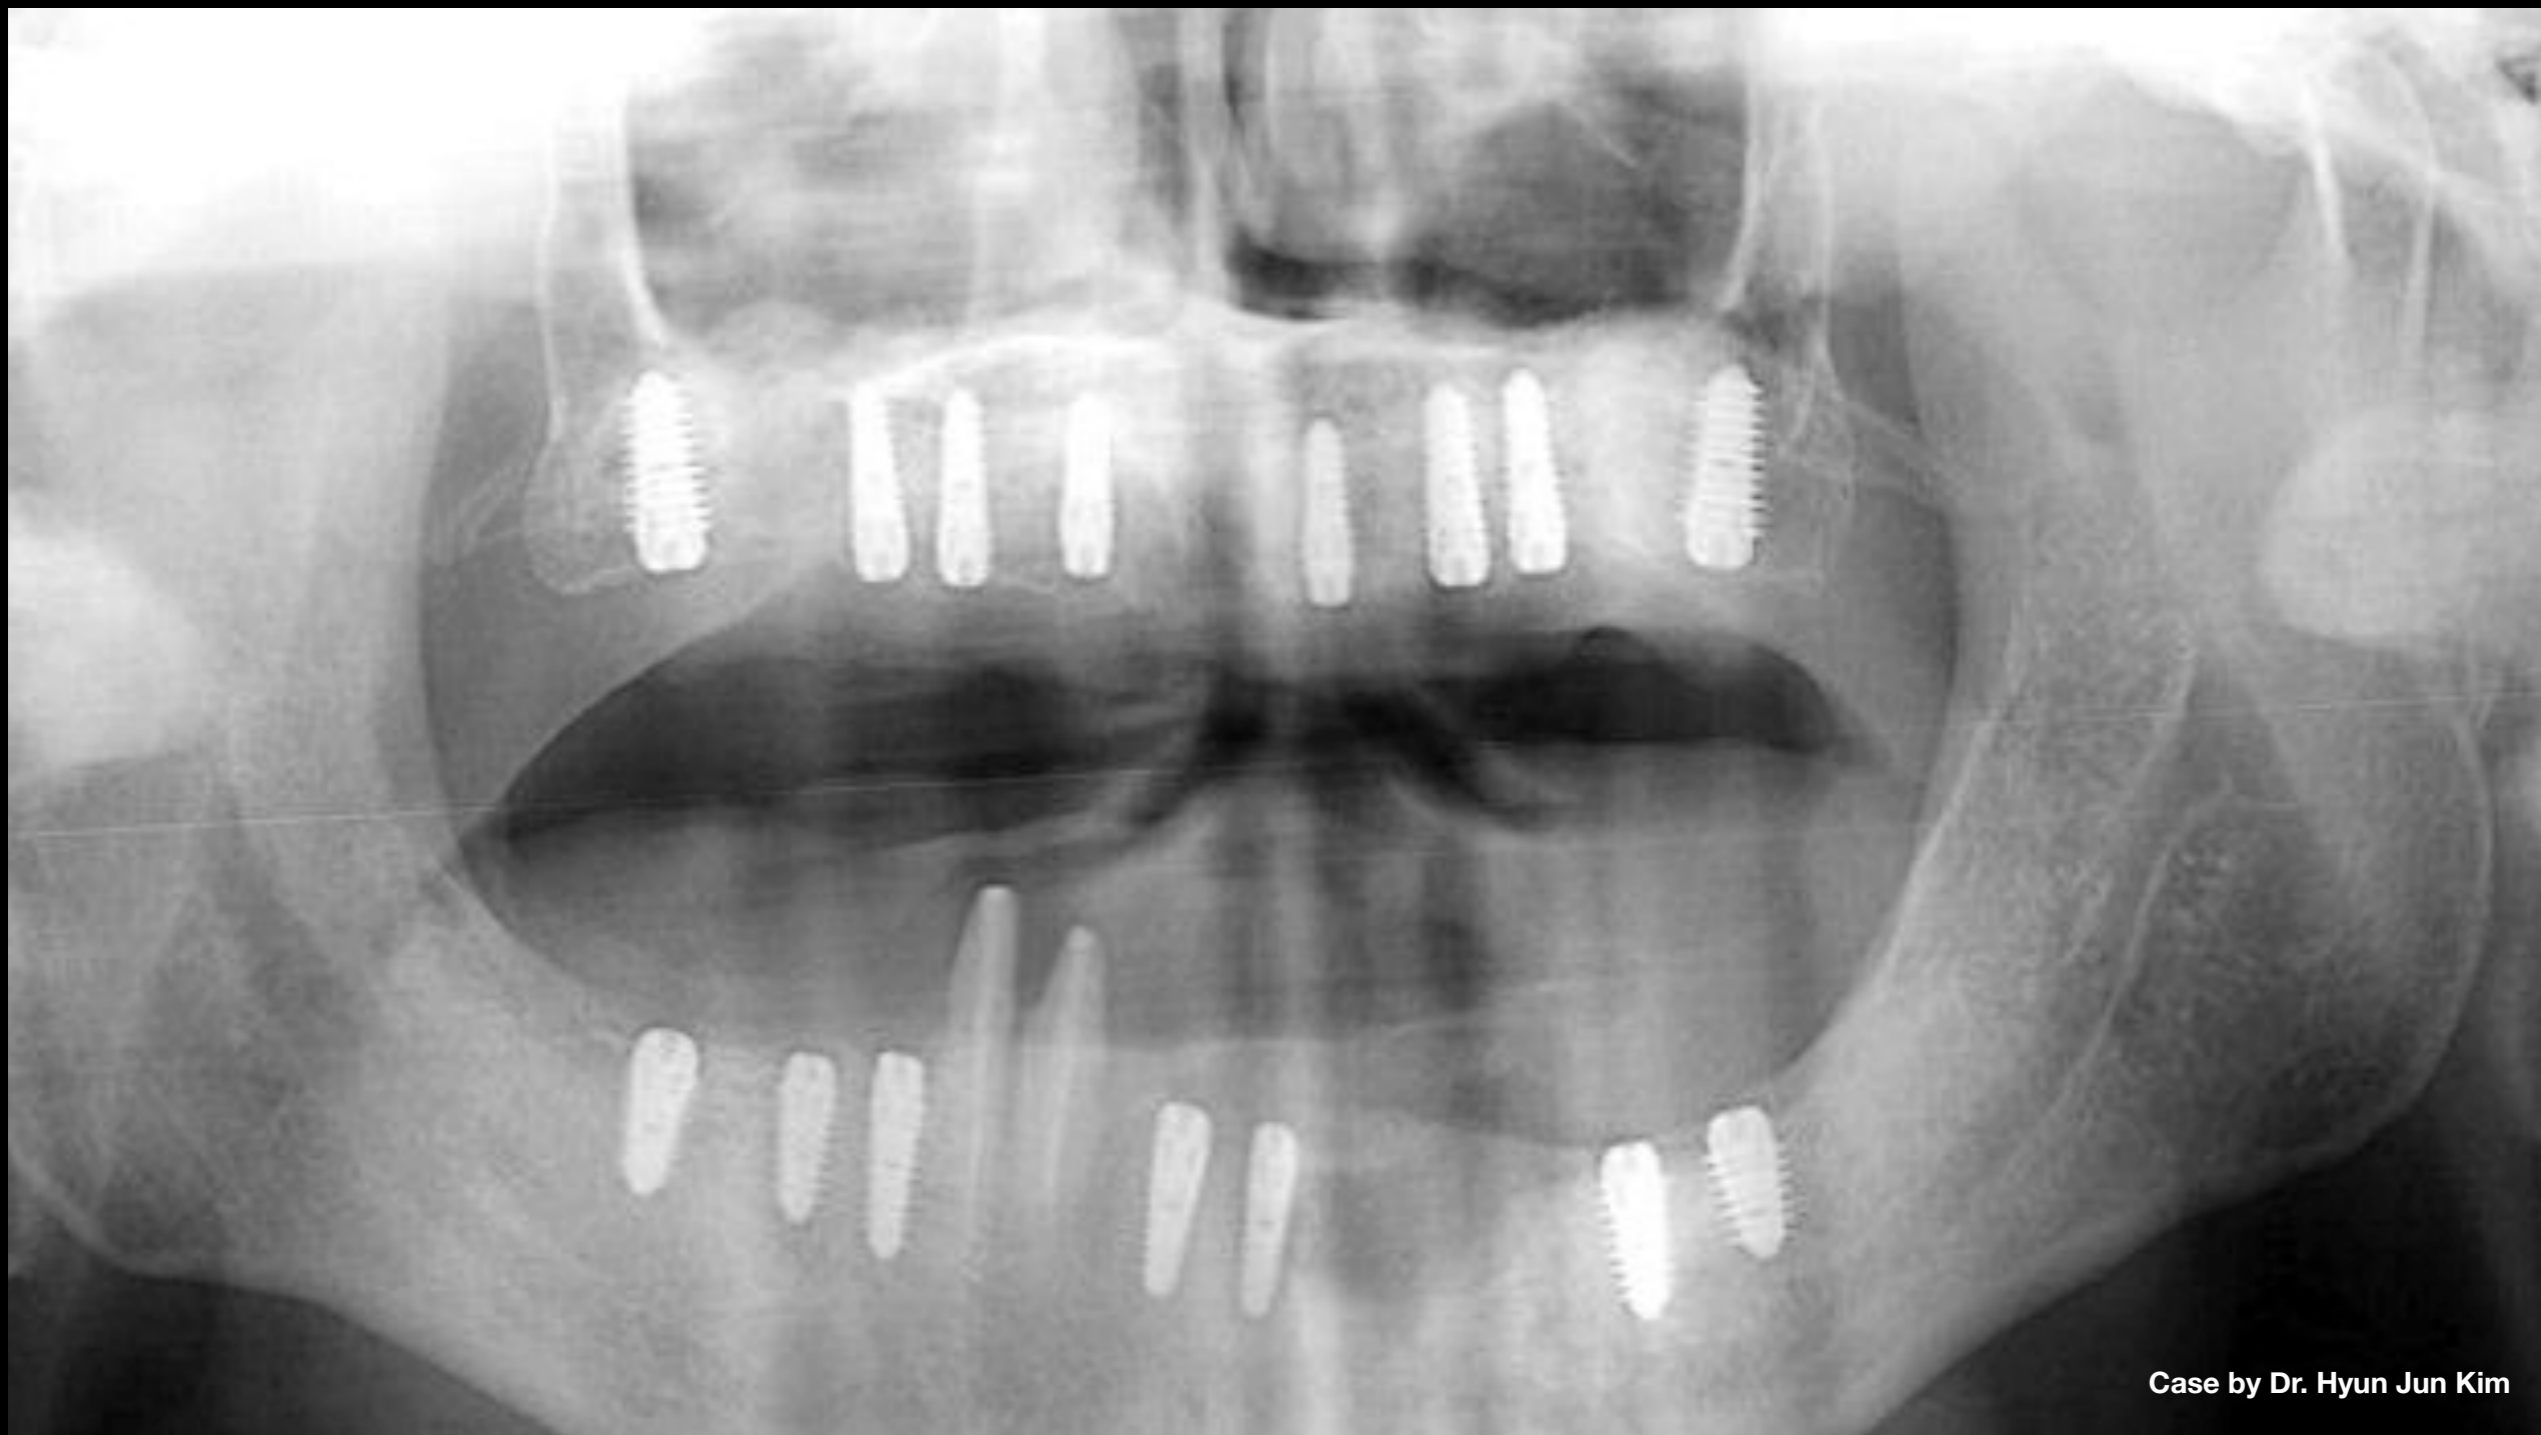
**Clinical Case:** Post-op panoramic scan (maxilla) showing placement of AnyRidge implants after bilateral sinus graft

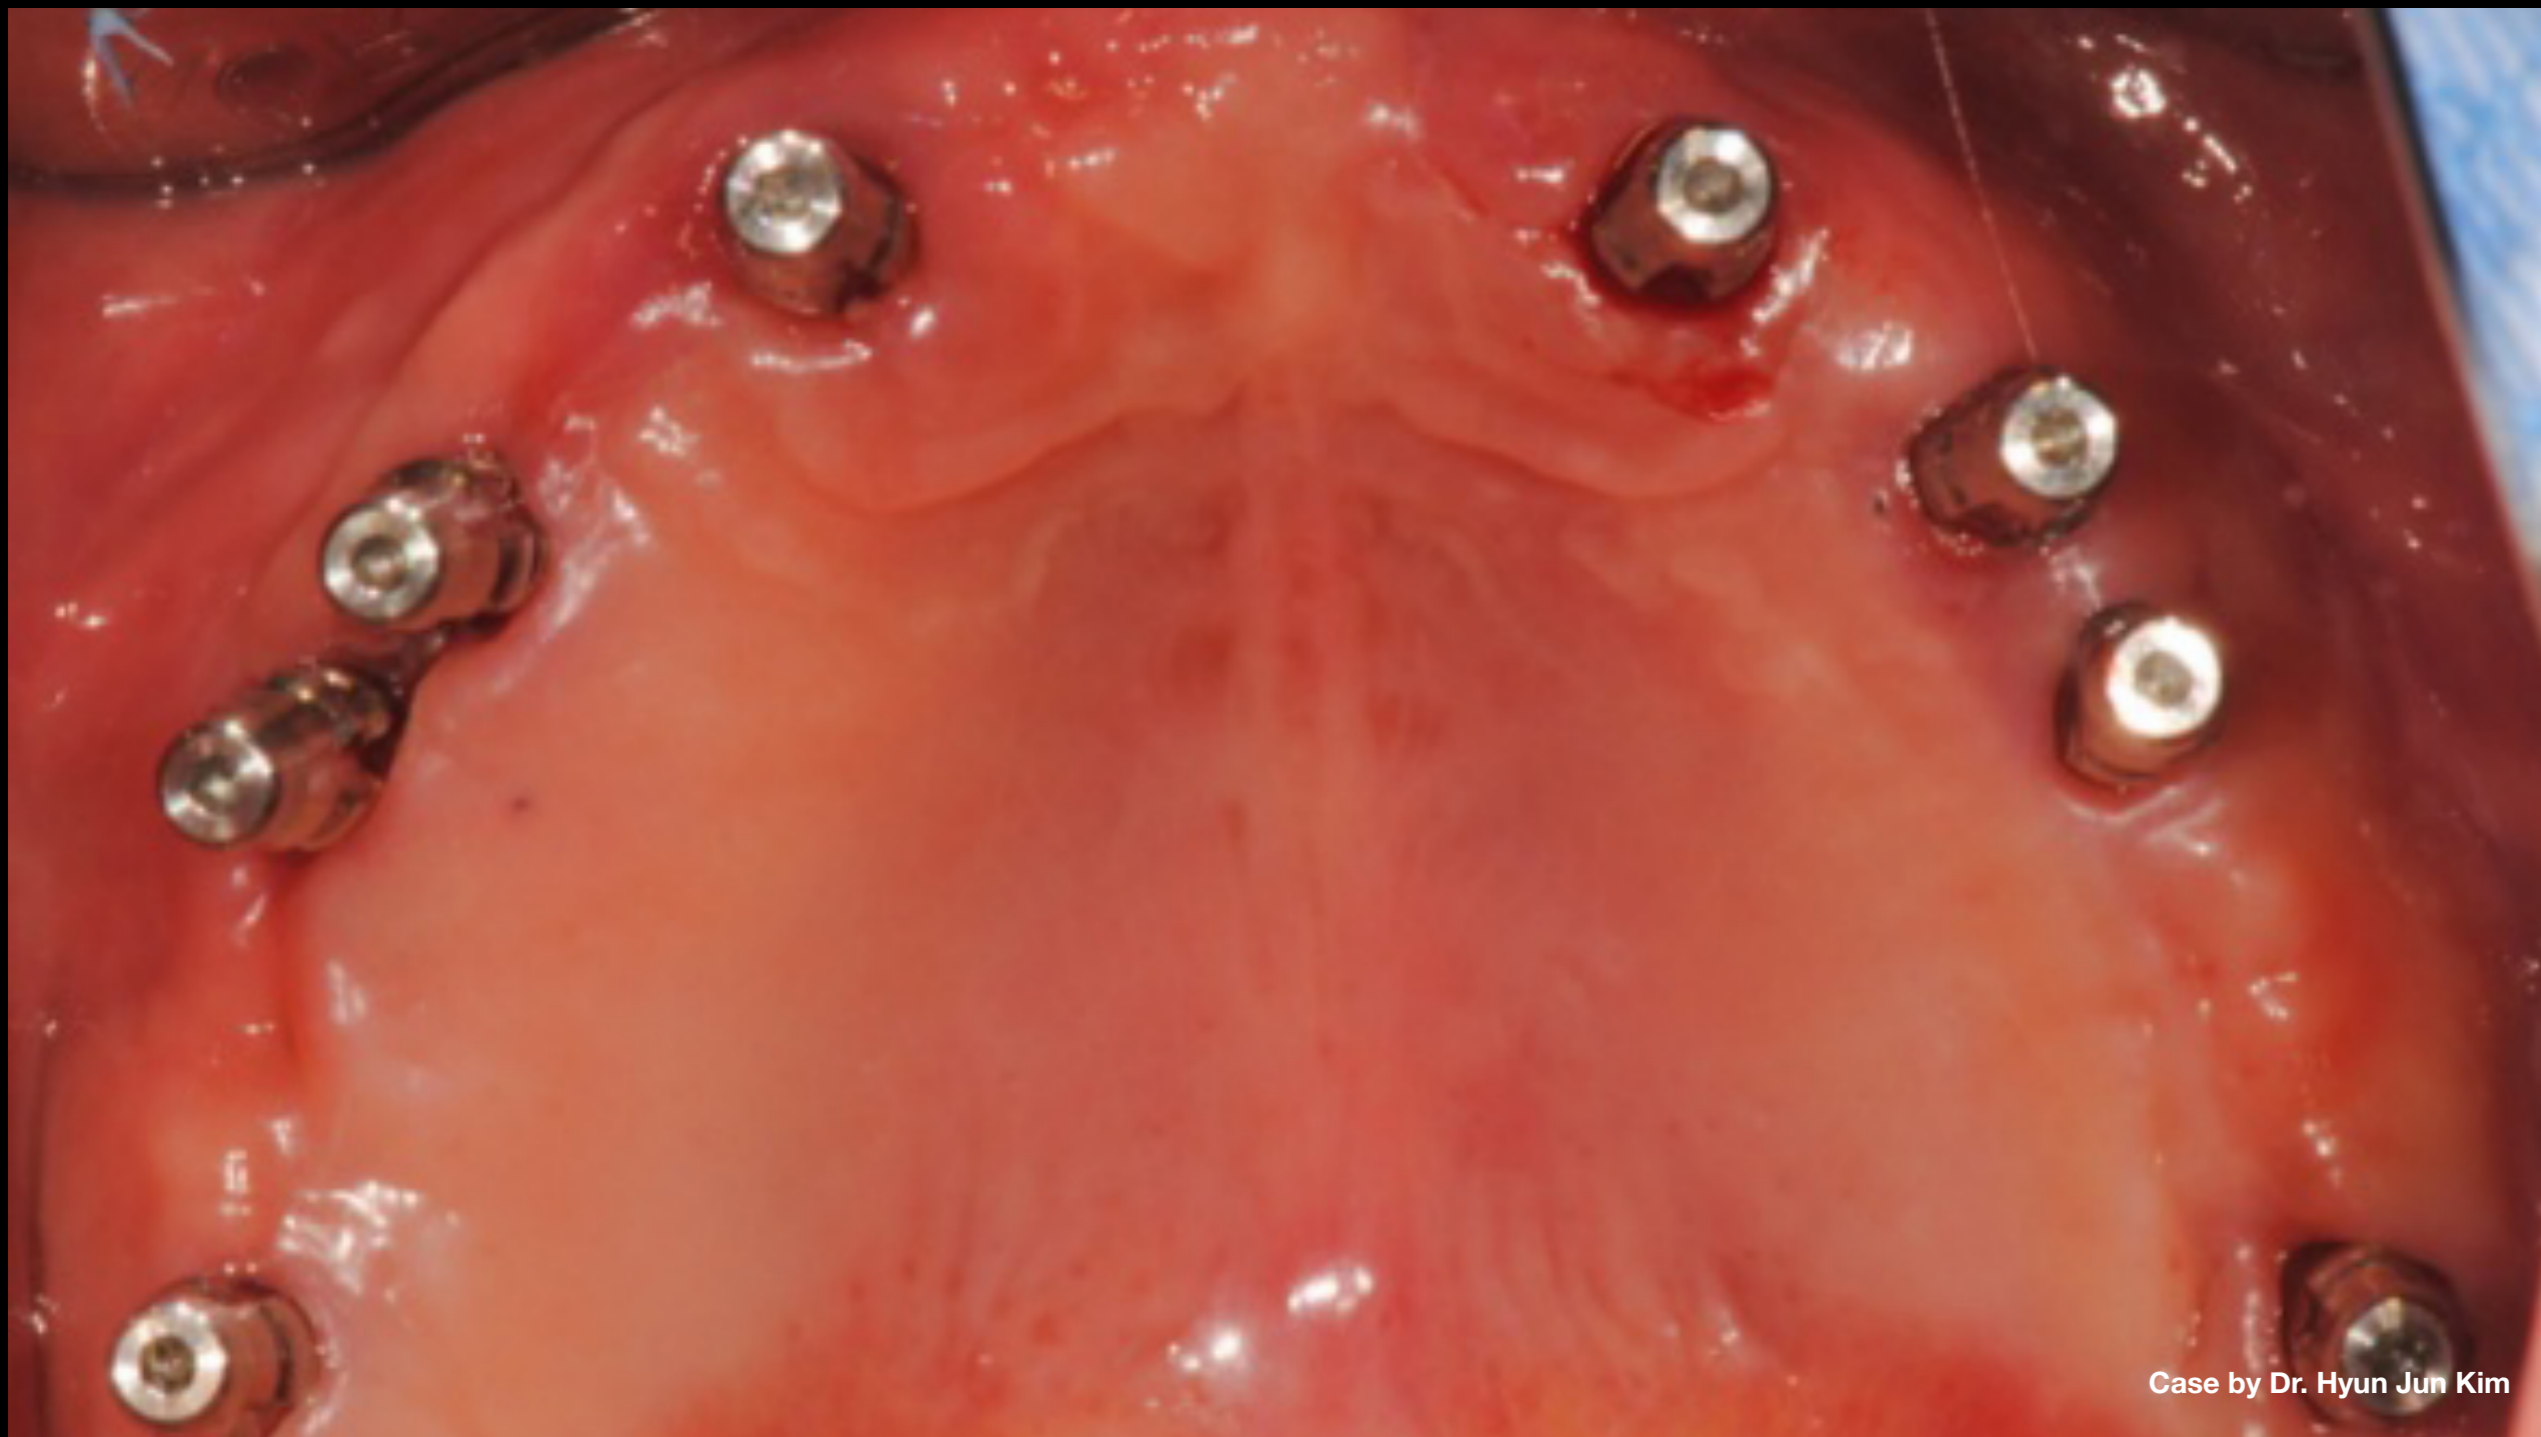
**Clinical Case:** PR impression taken using transfer-type impression coping

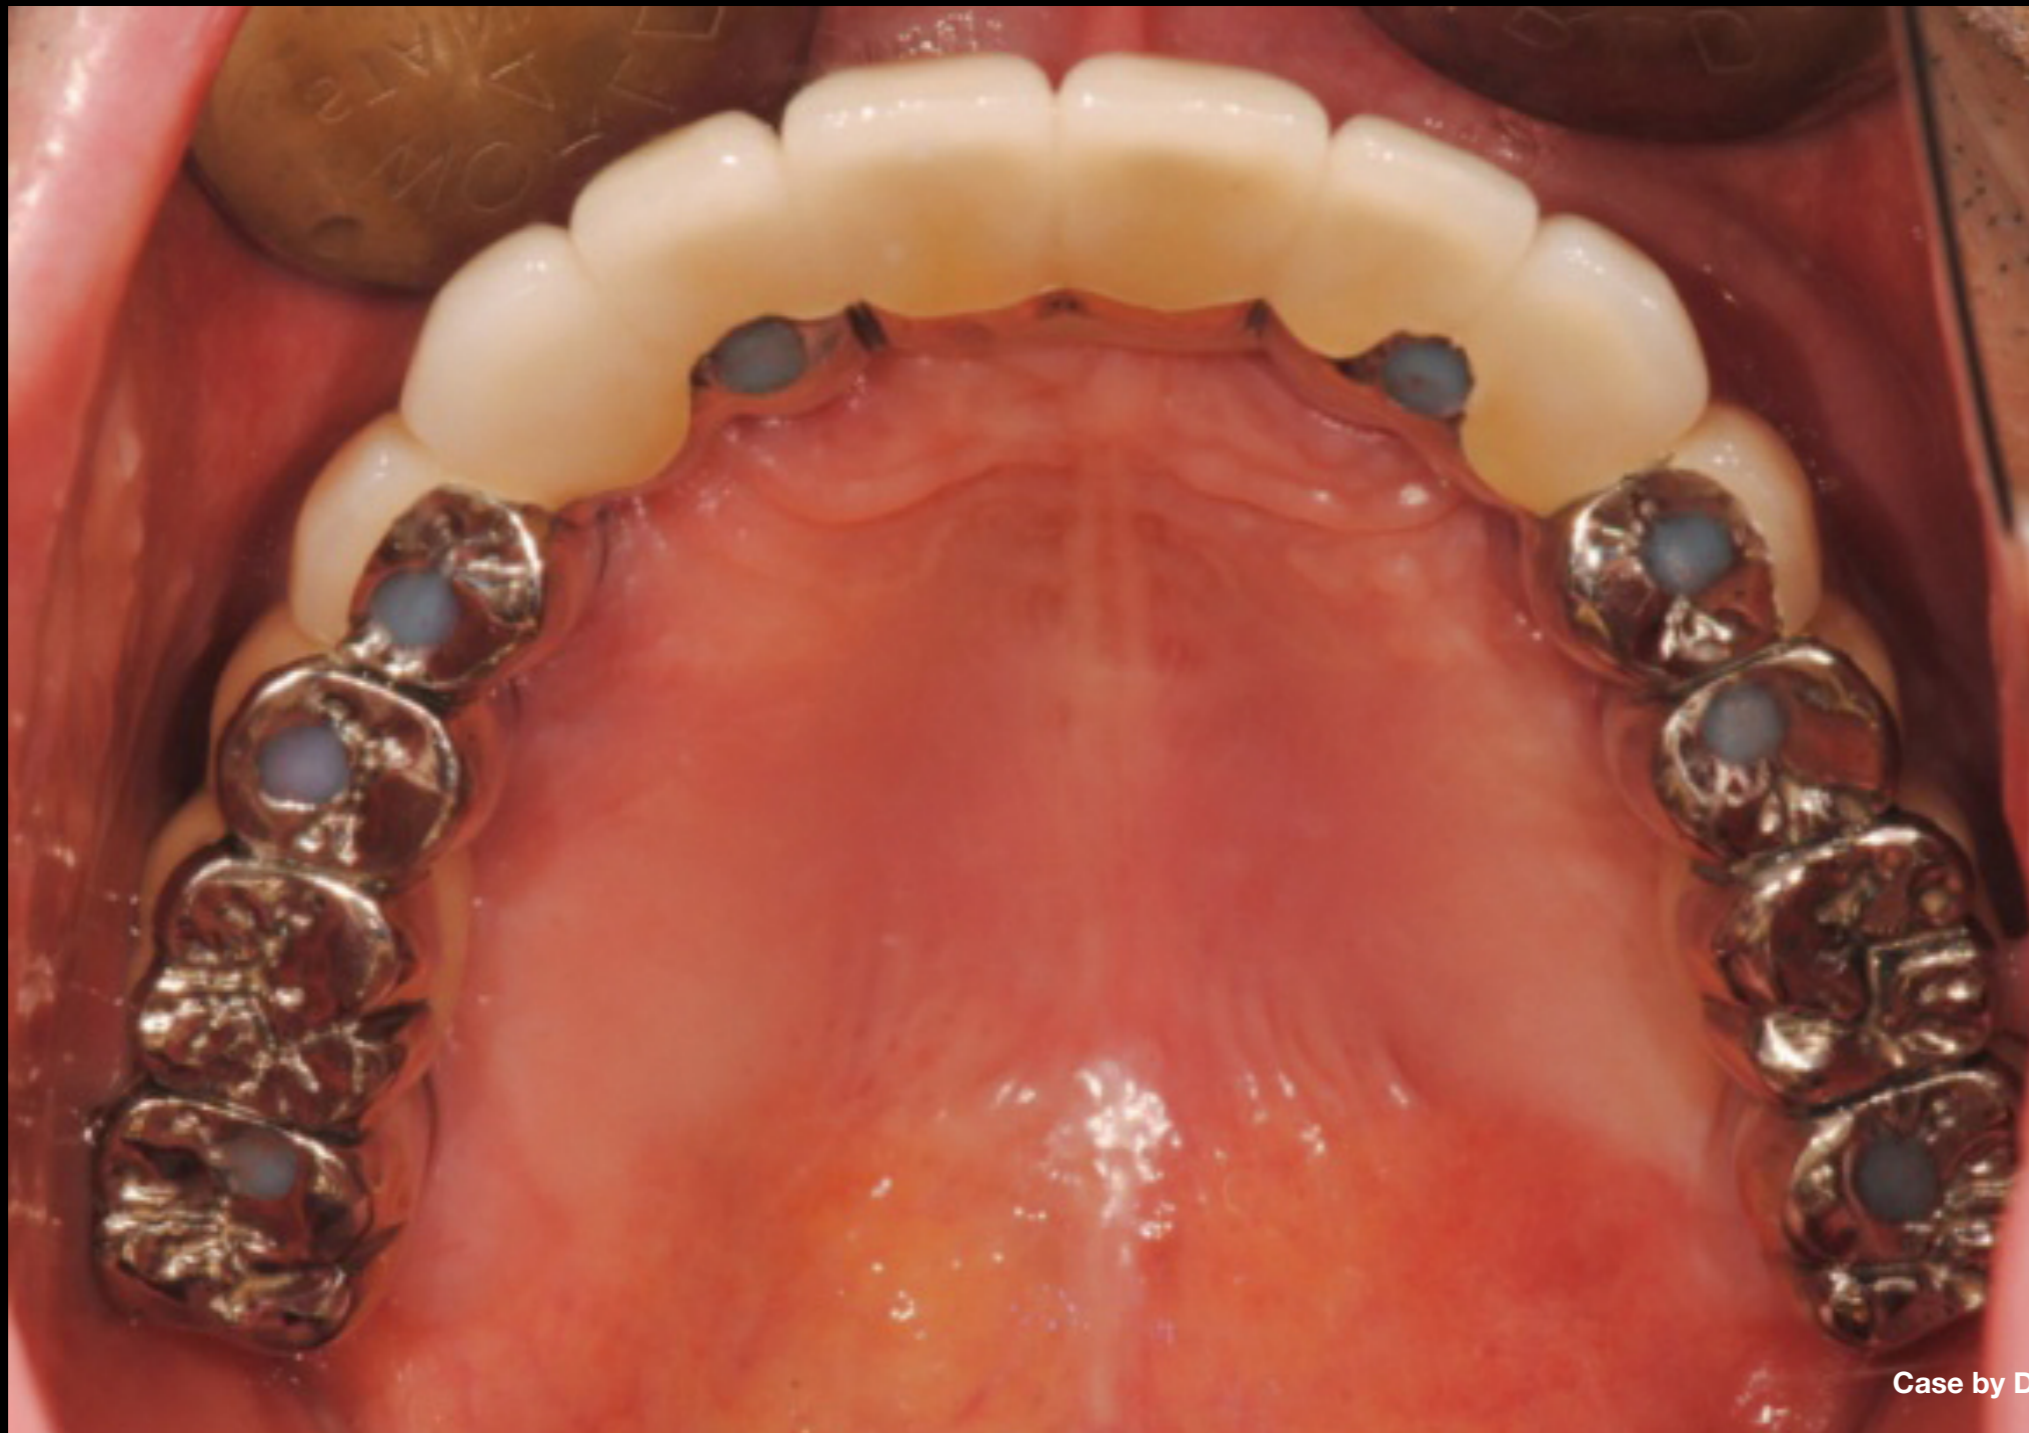
**Clinical Case:** Due to height of posterior teeth & history of night bruxism, 1-unit restoration was made for cross-arch stabilization & gold occlusal surface used to avoid porcelain fractures

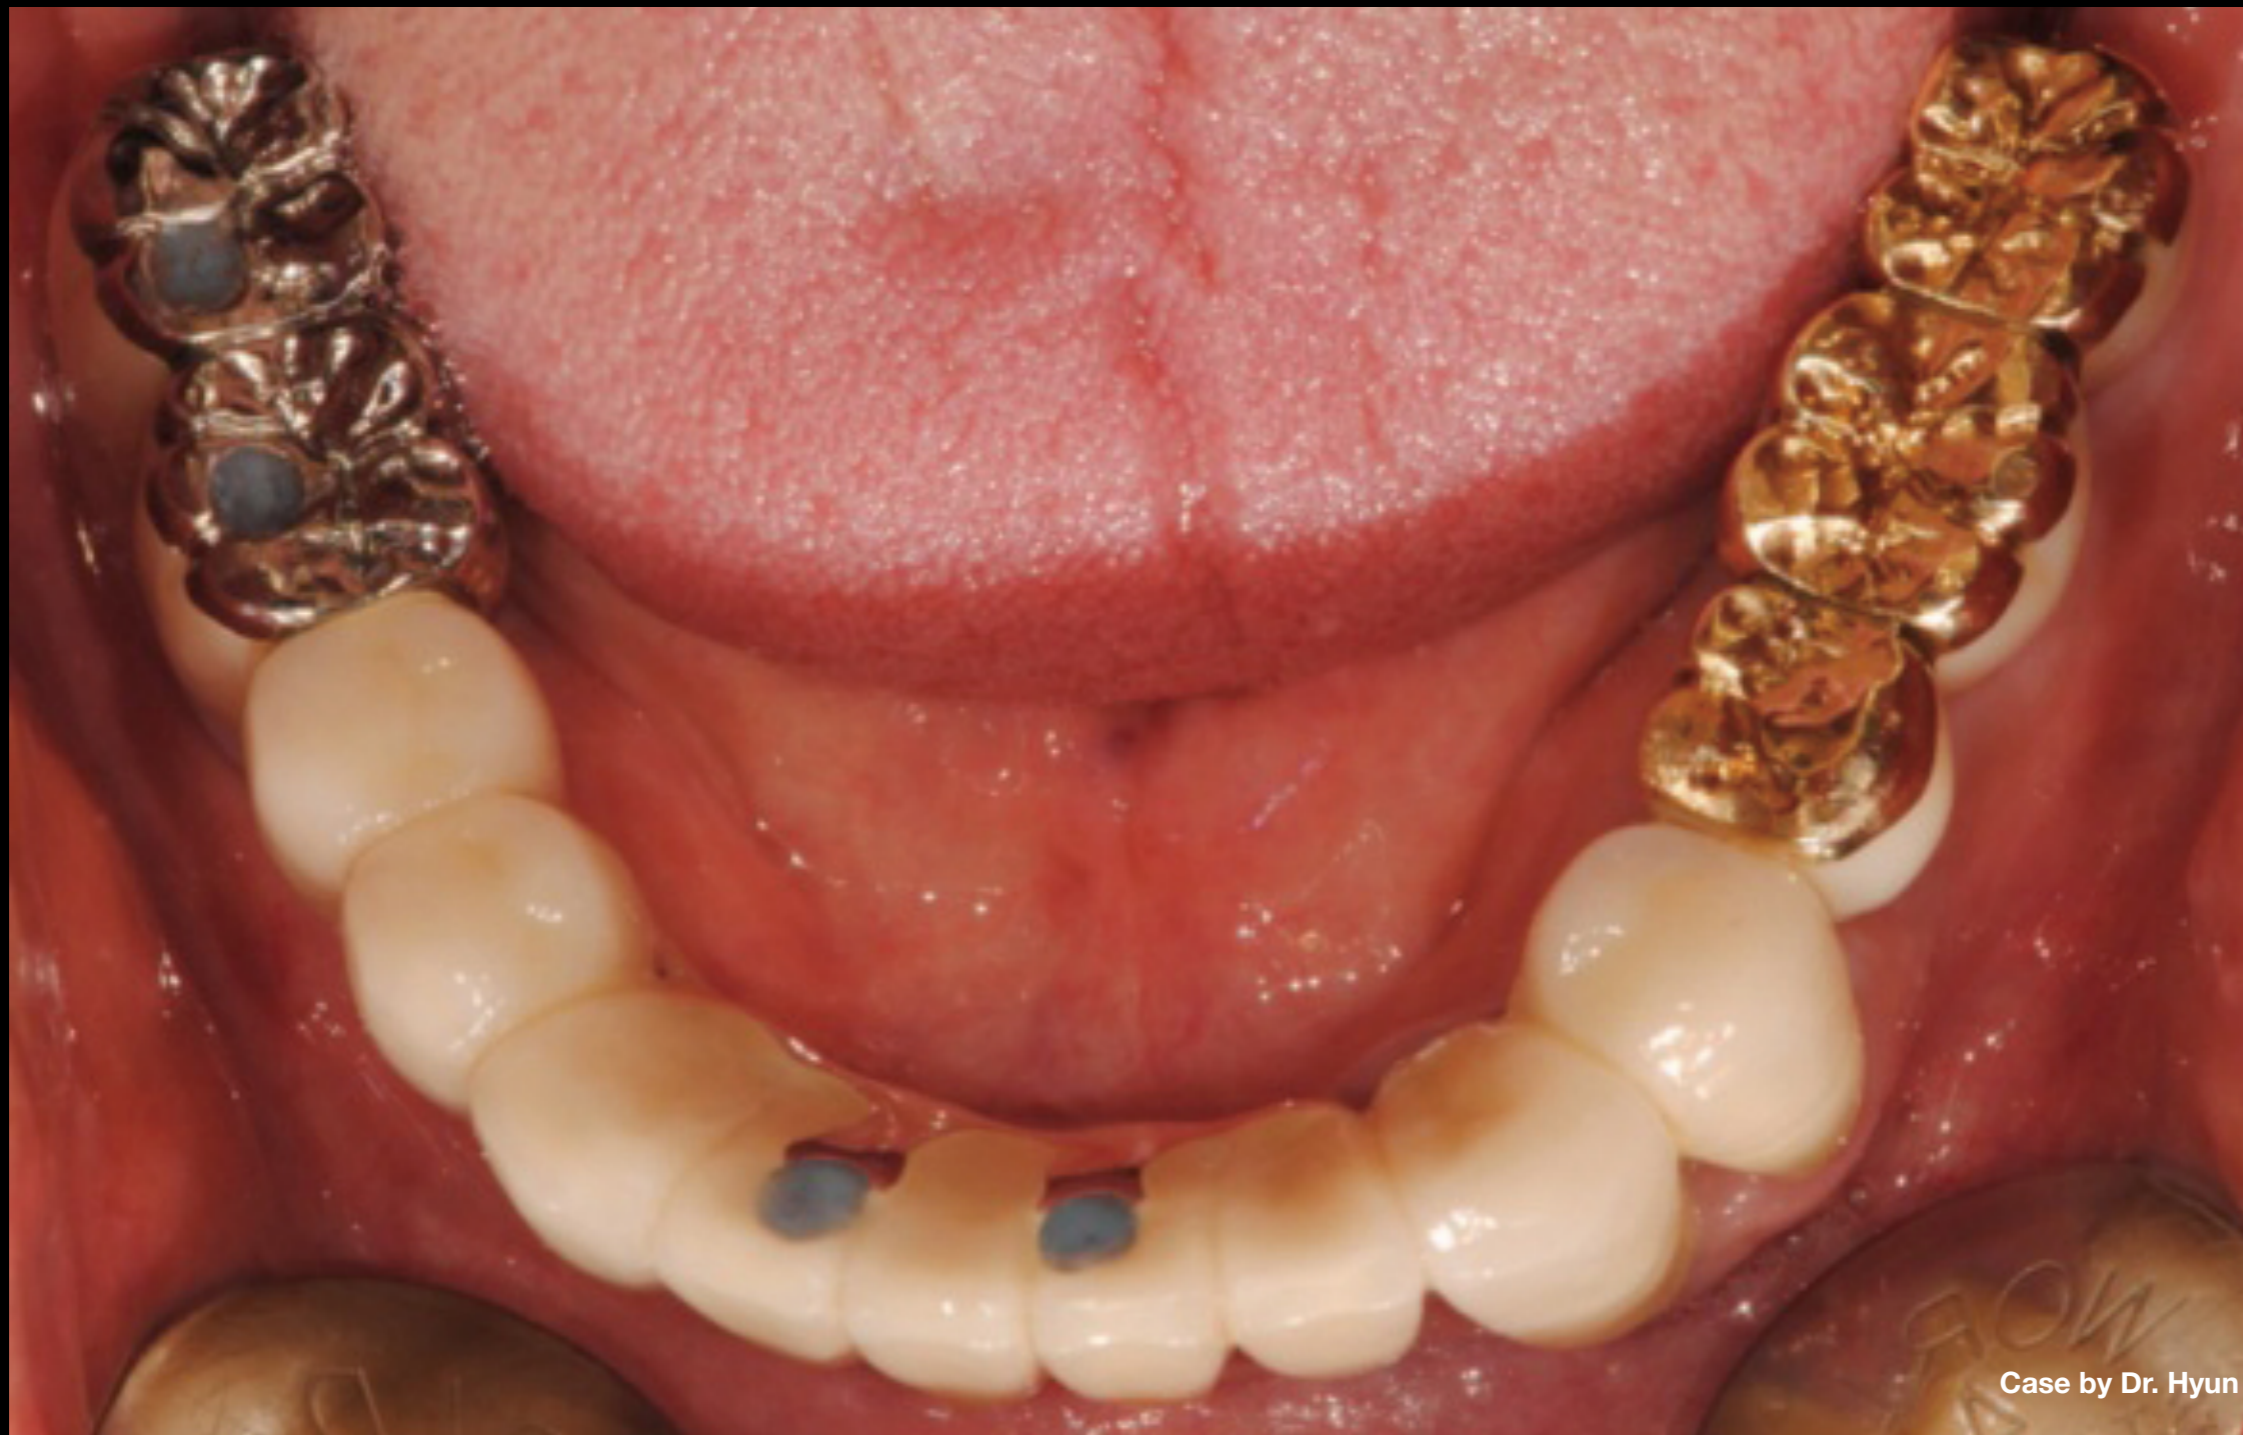
**Clinical Case:** Due to height of posterior teeth & history of night bruxism, 1-unit restoration was made for cross-arch stabilization & gold occlusal surface used to avoid porcelain fractures

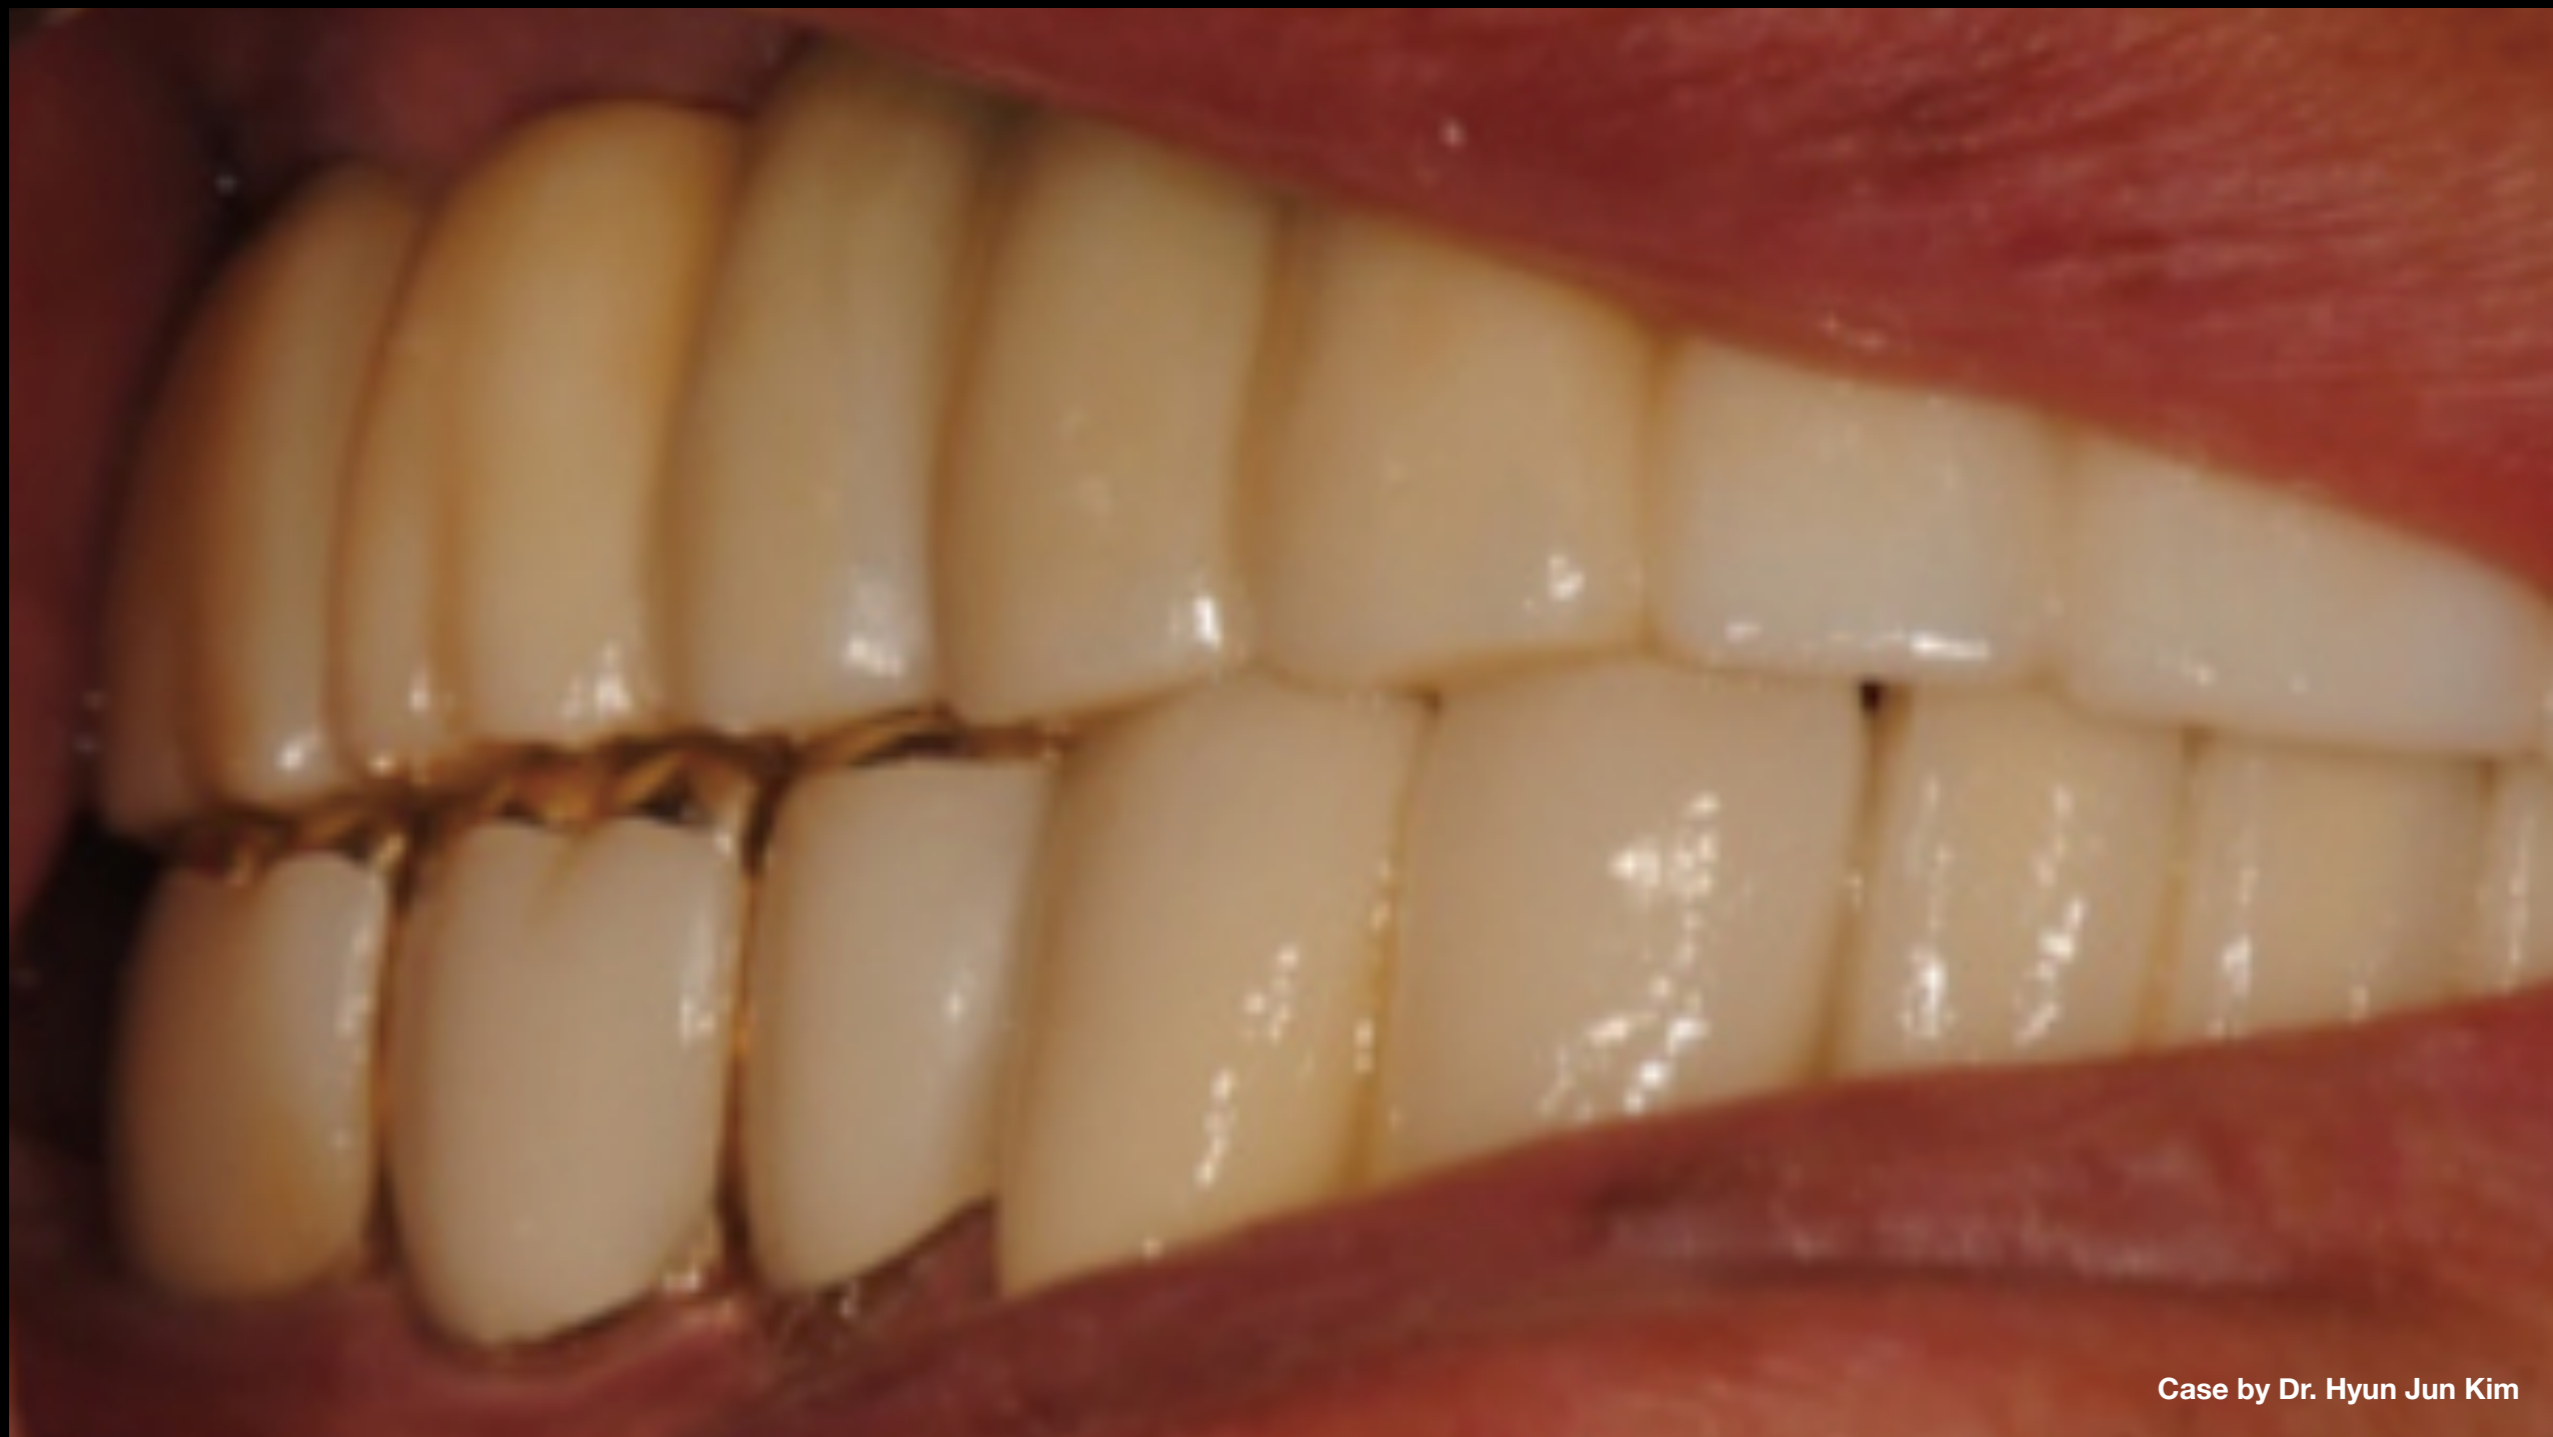
**Clinical Case:** 5-yr follow-up photos after replacement with full-zirconia prosthesis
