Full-mouth implants for mandibular & maxilla - restored using mixed prostheses

Dr. Hyun Jun Kim

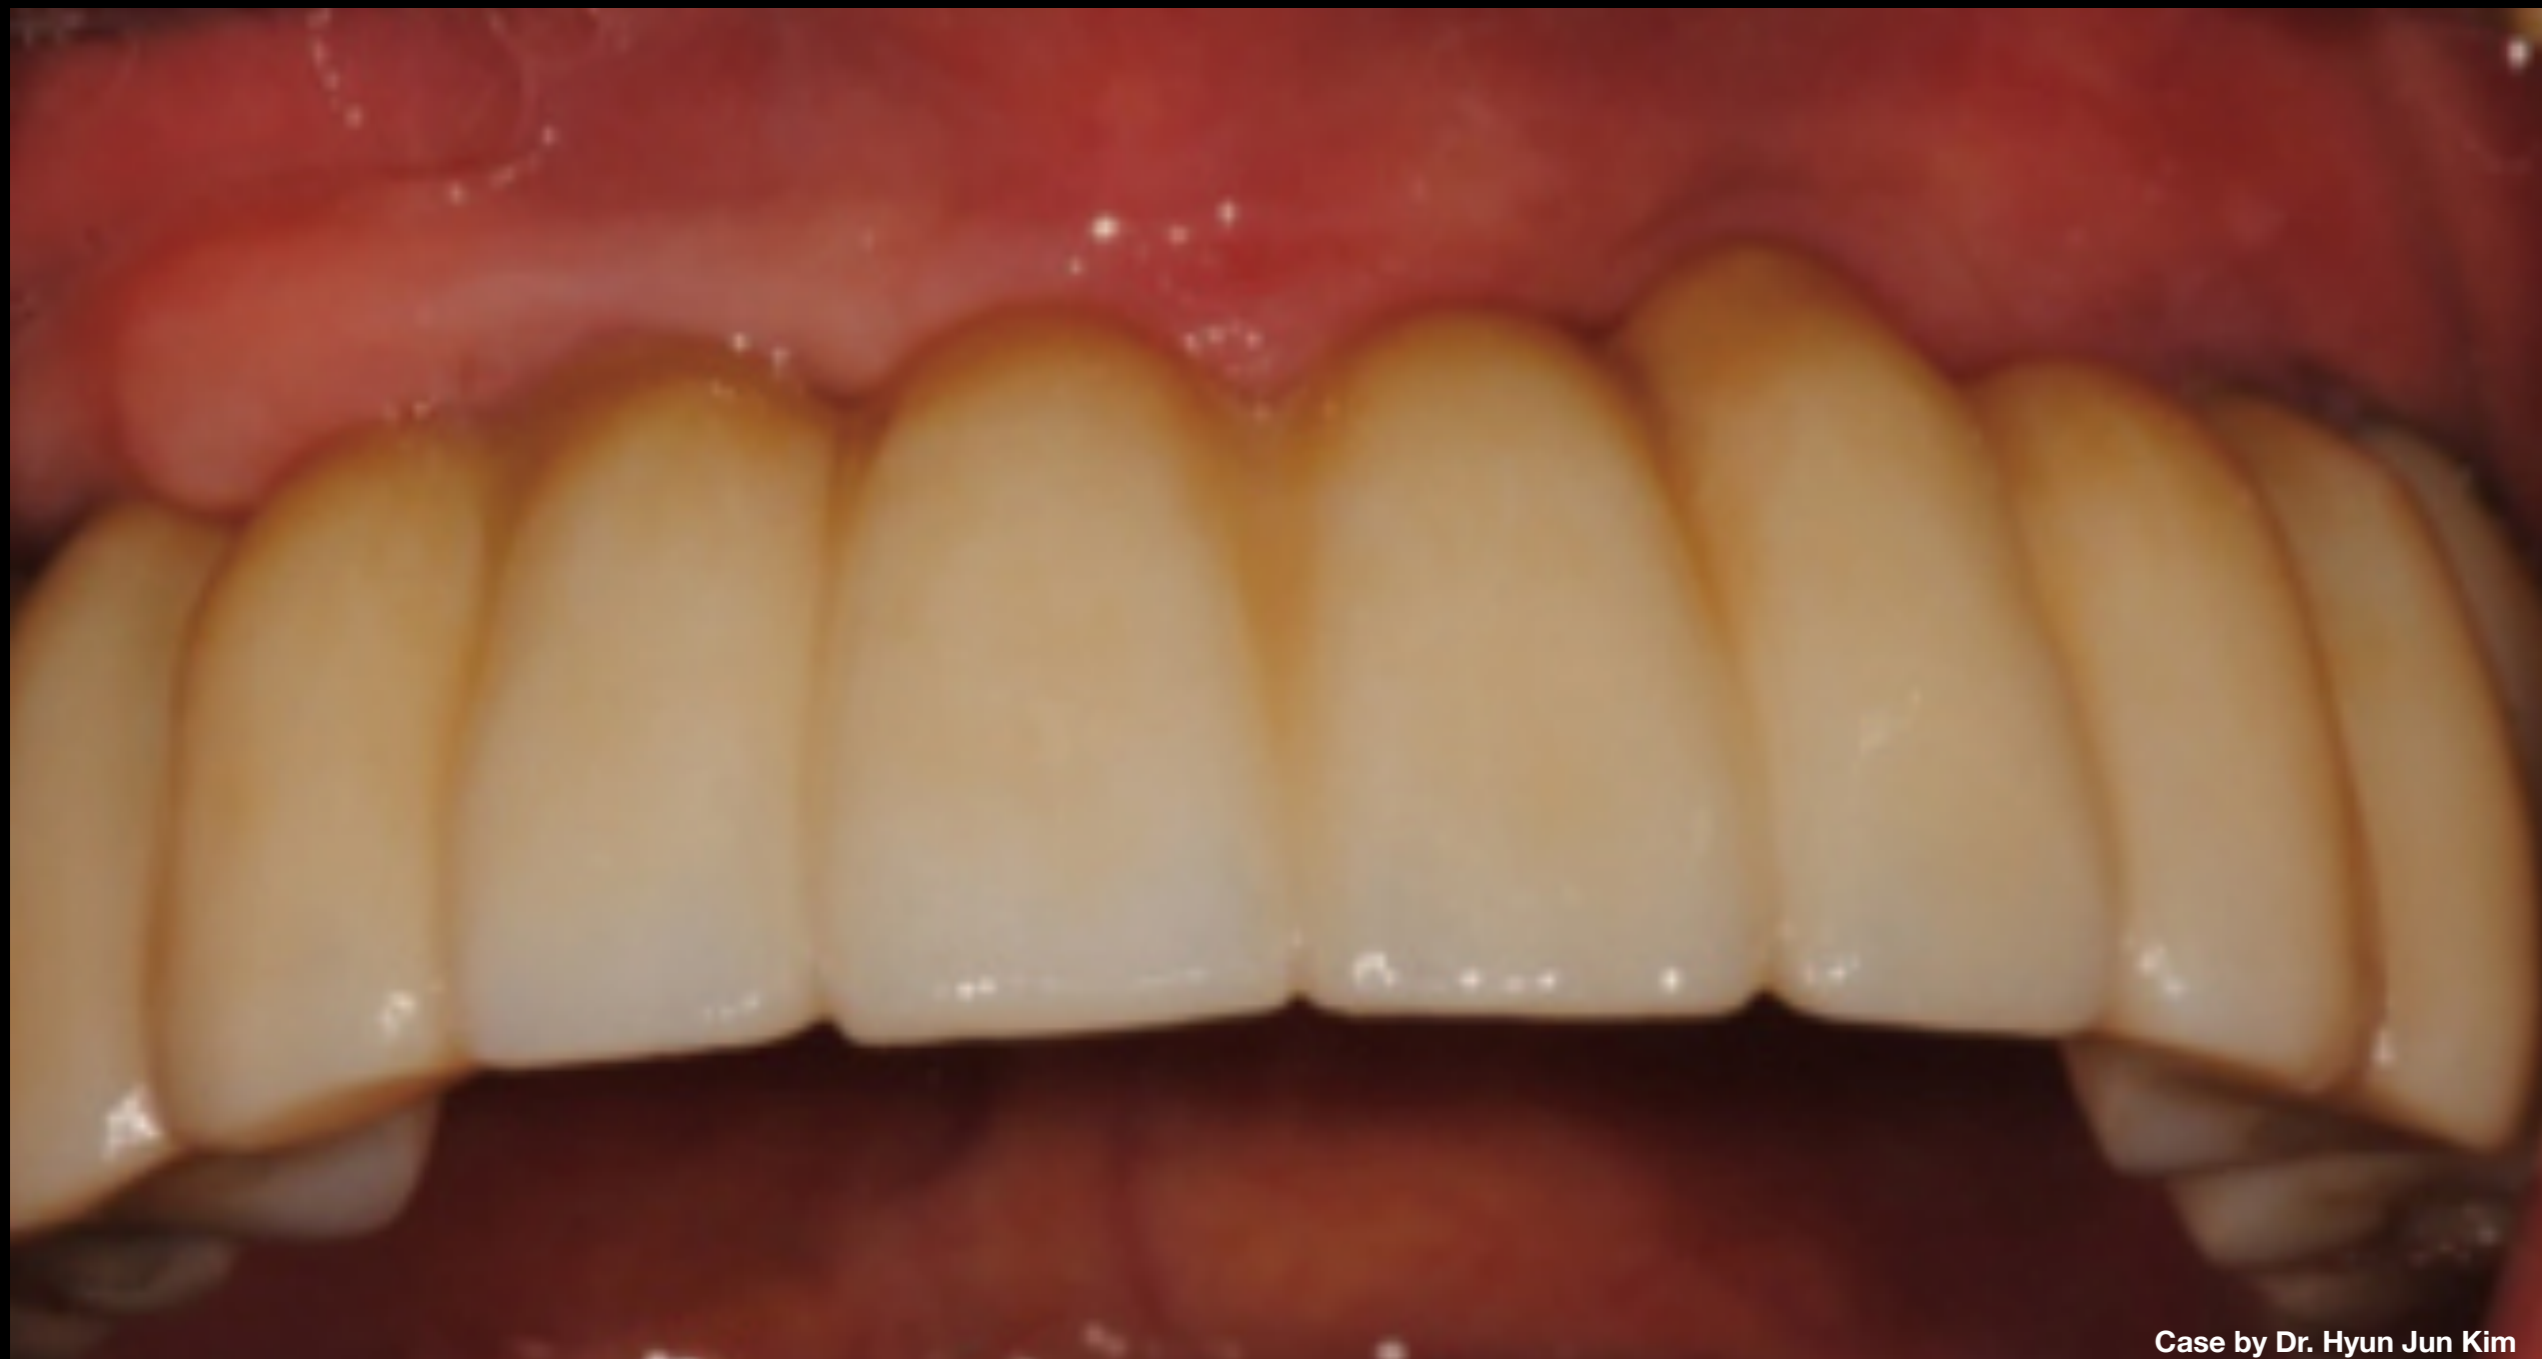
**Clinical Case:** 5-yr follow-up photos after replacement with full-zirconia prosthesis
